# Seeing is believing...

## A case study in handling and explaining occlusal disease

# Case Report

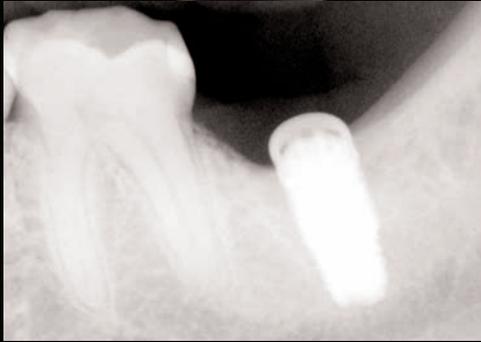
**Fig. 1** Existing implant in lower left #18 area.

A middle aged lady reported to my office with a request to have an implant crown placed on an integrated implant in the lower left #18 area (*Fig. 1*). Upon cursory examination, I observed signs of severe wear, occlusal disease, throughout the mouth and quite notably in the lower left quadrant (*Fig. 2*). I informed her of my concern, that implant success or failure after osteointegration was largely dependent on having proper distribution of the biting forces. I assured her we'd restore the implant for the greatest potential for long term success and asked for the opportunity to study her case further prior to making restorative decisions. She rescheduled for a complete examination which included (1.) full mouth x-rays, (2.) nine intraoral photographs (Canon Digital Rebel), (3.) Panorex, and (4.) mounted study models (SAM III) in centric relation.

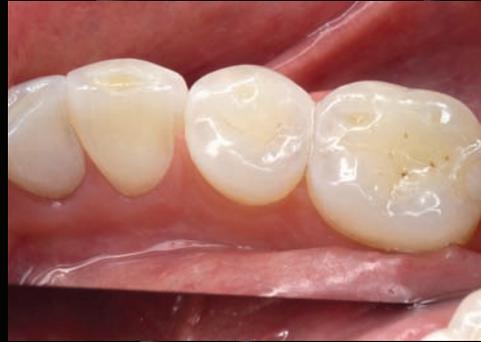
**Fig. 2** Lower left arch for implant crown.

The patient's history included tooth loss of #18 due to a fracture of the crown as well as a recent history of loosening, fracturing and early replacement of all-ceramic restoration on #8 and 9 (Figs. 2 & 3). She stated she has a habit of grinding her teeth and felt that was contributing towards the crown failure. Additionally, the patient was not pleased with the appearance of her smile as she felt her teeth were too short. Her long term goal was to keep her natural teeth for life and avoid repeated dental treatment.

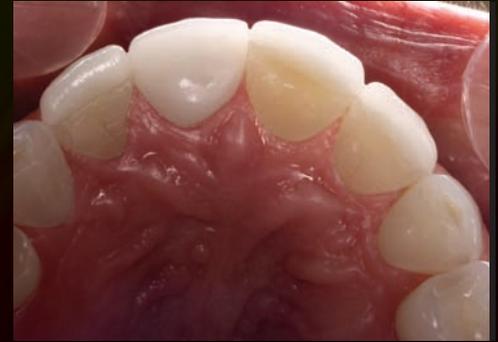
**Fig. 3** Upper occlusal view before treatment.

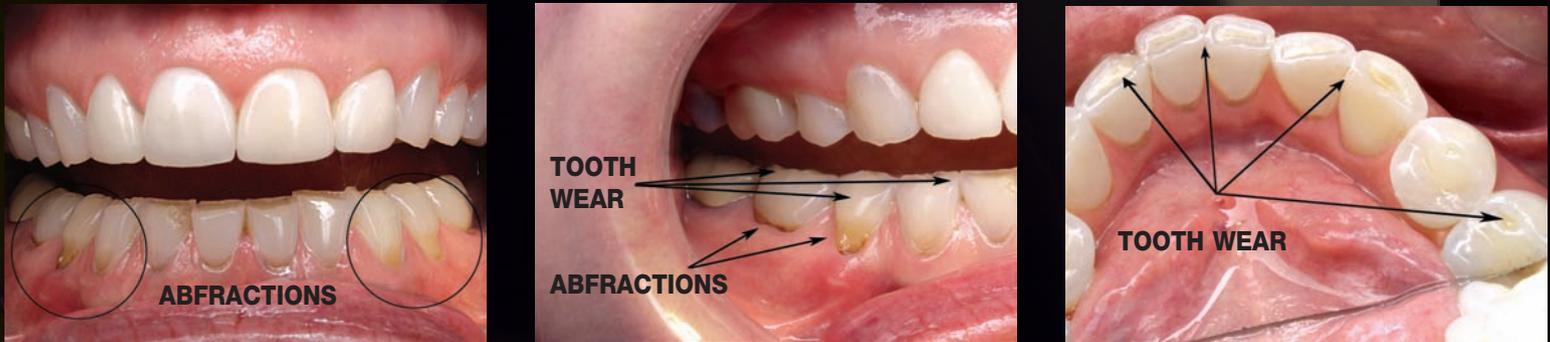
Figs. 4, 5, 6 Tooth wear and abfractions.

There was excessive hypertrophy of the masseters as well as the temporalis muscles. The mandible had full range of motion in all possible movements. There were no intracapsular disorders of the TMJ as determined by Doppler auscultation and load testing. There was severe wear throughout the mouth as well as abfractions along with slight tooth mobility. There was a CR contact on the distal of #19, with a 2mm vertical component and a 2mm forward component into maximal intercuspation (MI). There were interferences in lateral excursions on the working and non working sides bilaterally. Protrusive was WNL.

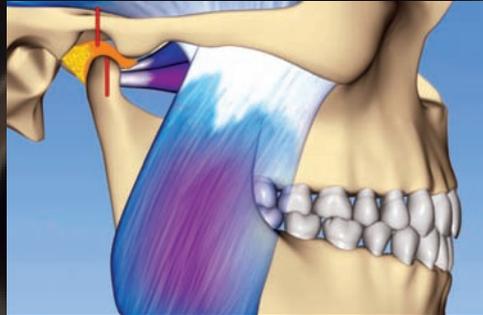
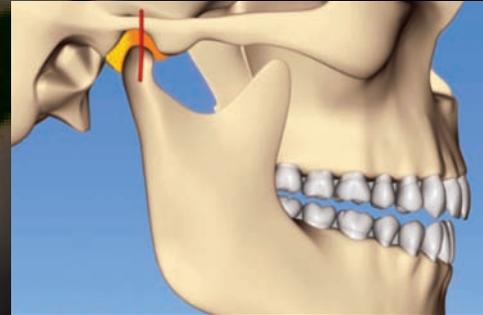
**Figs. 7, 8** Animation showing muscle function and removing tension in pterygoids.

The patient had experienced remarkable relief of facial muscle soreness with the deprogrammer so I began by educating her on the reason behind this success. Through animations (*illustrated in Figs. 7 & 8*), the client could see how the muscles closed the jaw and allowed the joint to fully seat, removing the tension in the pterygoid muscles. This had the net effect of changing the mandible position and causing the teeth to fit differently after nighttime usage.

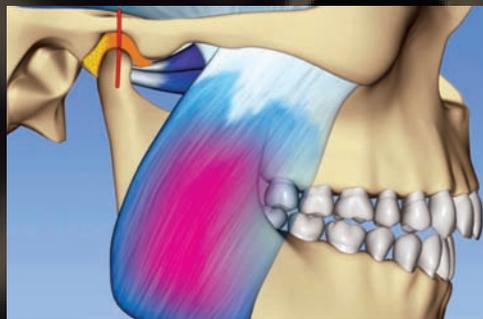
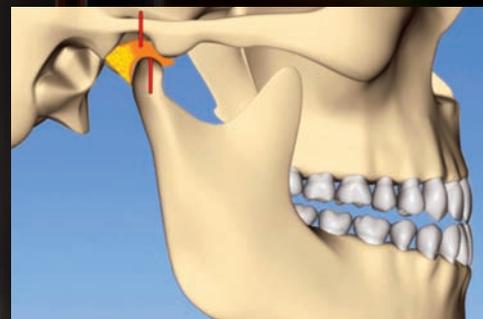
**Figs. 9 & 10** Animations contrasting stable (left) and unstable (right) bites.

I was able to show the patient the difference between a stable bite, with CR in harmony with MI and no ability to slide forward and backwards on the back teeth, and an unstable bite by showing two contrasting BiteFX animations (*Figs. 9 & 10*).

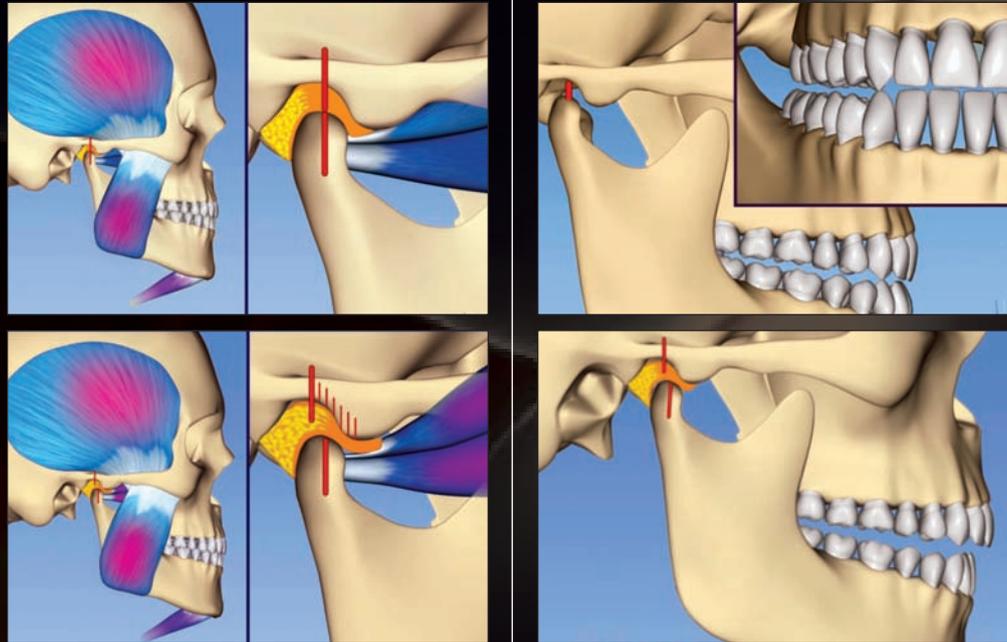
**Figs. 11, 12** Normal muscle function (left) compared with muscle hyper-activity (right).

**Figs. 13, 14** Animations illustrating anterior guidance.

To explain her muscle tenderness I showed her two animations; one illustrating normal muscle function (*Fig. 11*) and the other showing hyper-muscle activity (*Fig. 12*).

It was easy to illustrate, that when the jaw closes into a stable bite, it requires no usage of the muscles that position the jaw forward and sideways.

The patient exhibited severe wear and lateral interferences on both the working and balancing sides. Using BiteFX animations she could visualize the destructive effects of her existing occlusal disease, and the benefits of proper anterior guidance as snapped in figures 13-16.

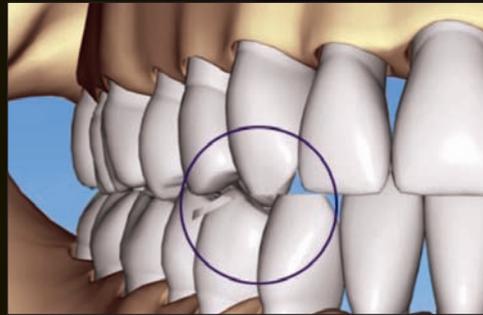
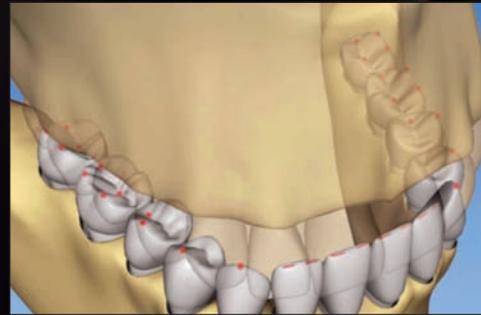
**Figs. 15, 16**  
Animation illustrating the effects of lost anterior guidance.

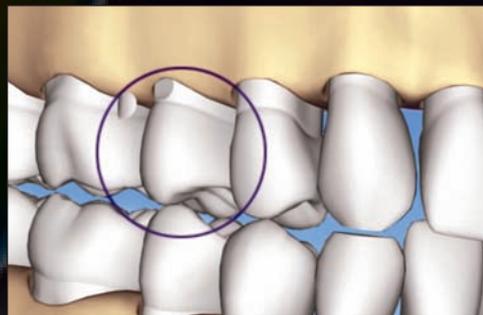
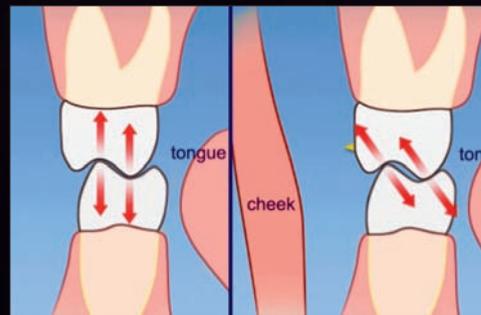
**Figs. 17, 18**  
Animations showing ideal tooth contacts (left) and comparing proper and destructive tooth contacts (right).

The animations illustrated in figures 17 and 18 showed the patient proper tooth contacts which minimize the contact, wear and stress to the teeth as compared to destructive contacts which can wear, move or break teeth.

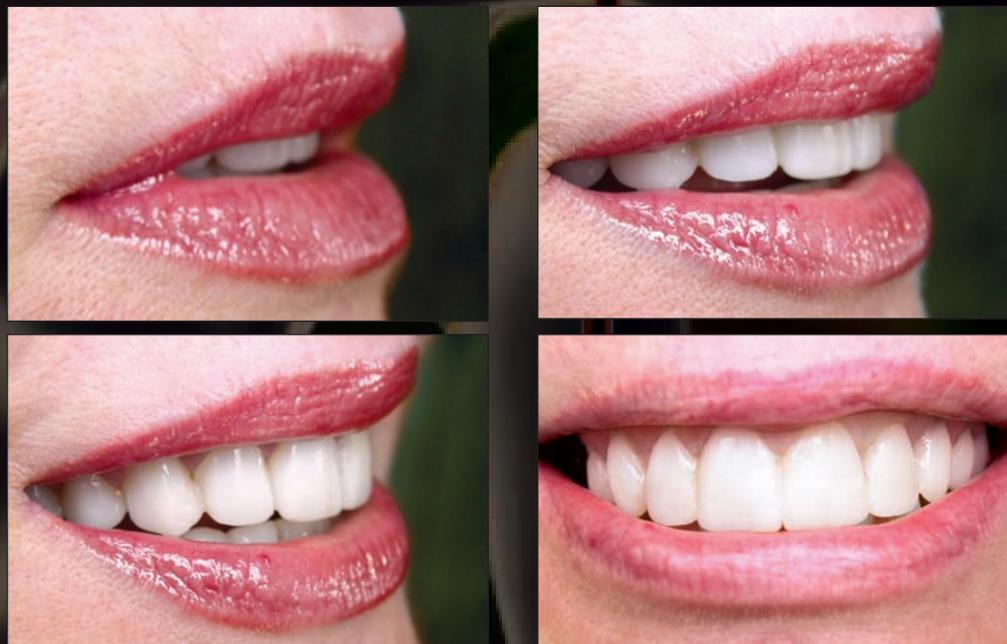
**Figs. 19, 22**  
The patient's  
temporaries.

This is the period where the newly increased VDO is evaluated with emphasis on speech and esthetics. The temporaries (Figs. 19 - 22) were modified to the patient's desires (i.e. more pointed canines), and alginate impressions, digital photos and face-bow records were given to the lab to create the final restorations.

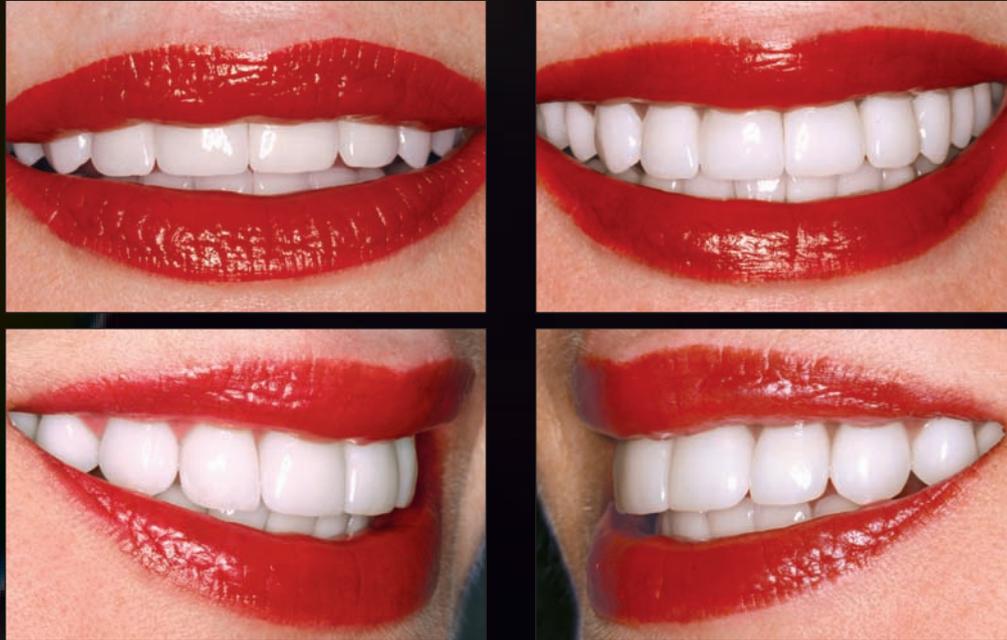
**Figs. 27-30**  
Final restorations.

There was no hint of a CR slide and all eccentric jaw motions were WNL!

The final restorations (Figs. 25 - 30) were placed using RelyX bonding agent for the refractory porcelain and Fuji GC luting cement for the posterior PFMs. The delivery appointment went smoothly and required only 'spot adjusting' in several areas. ⇨
